## ANALYSIS OF THE CAUSES AND CIRCUMSTANCES OF THE COLLISION BETWEEN TWO SHIPS IN CONSTANTA PORT

Lecturer PhD. Cristian Andrei<sup>x</sup>

*Constanta Maritime University<sup>x</sup>*

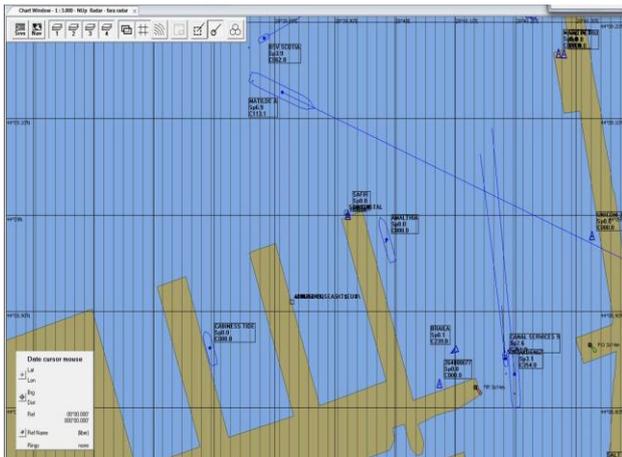
At 00:00:40 hrs., the container ship had a course of 115 degrees and a speed of 7 knots, this course being a cross course with the course of chemical tanker ship of 356 degrees and a speed of about 2 knots (fig.1).

At the time when the avoidance manoeuver was confirmed by both pilots, the distance between the two vessels was about 3 cables, the chemical tanker ship being in a position exactly at the port entrance, a distance of 0.3 cables abeam from the red lighthouse (fig.1).

Figure 1 Position of ships prior commencement of avoidance manoeuver (capture from VDR) [11]

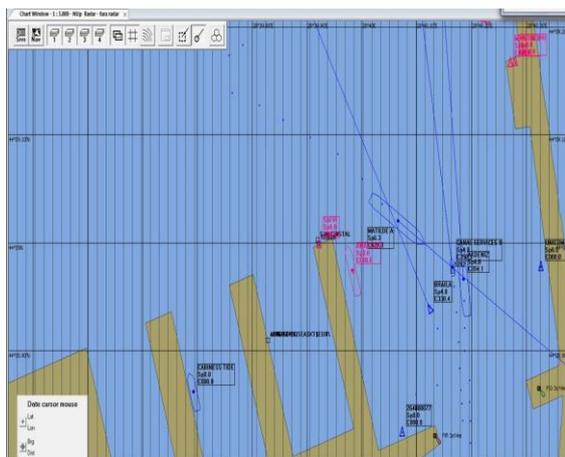
- At 00:00 52 hrs. the pilot of the container ship gave the command “rudder midship”.
- At 00:01:00 hrs. the pilot of the container ship ordered “rudder 20 degrees to Port” whilst the engine was full ahead with a speed of 8 knots and course of 113 degrees.
- At 00:01:26 hrs. the pilot of the chemical tanker ship ordered “stop engine”.
- At 00:01:28 hrs., whilst the pilot of the container ship noted that the chemical tanker ship is keeping her initial course of about 356 degrees, without no any change to portside according to the agreement between the pilots, decided to start the manoeuver for stopping the ship by ordering “stop engine” (fig.2).

Figure 2 Position of ships prior collision (Capture from VDR) [11]

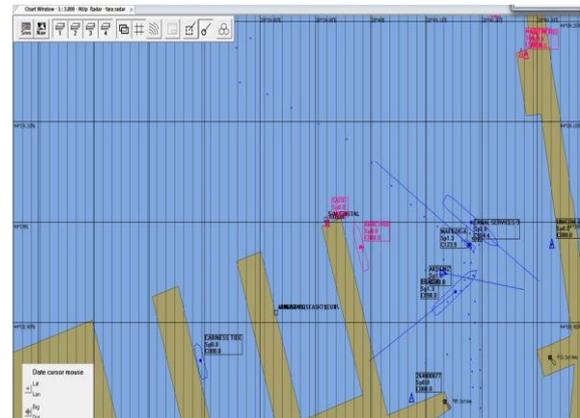
- At 00:01:42 hrs, the pilot of the chemical tanker ship ordered “full astern”.
- At 00:02:10 hrs, the two vessels collided, inside the port basin, at a distance of about 2 cables from the entrance. The chemical tanker came into collision with her bow to the starboard side of the container ship, near to aft part of cargo hold no.1 (fig 3).

Figure 3 Position of ships at the time of collision (capture from VDR) [11]
